## **AWI RESPONSE AT B.E. PAYNE WTP**

### **THE PROBLEM**

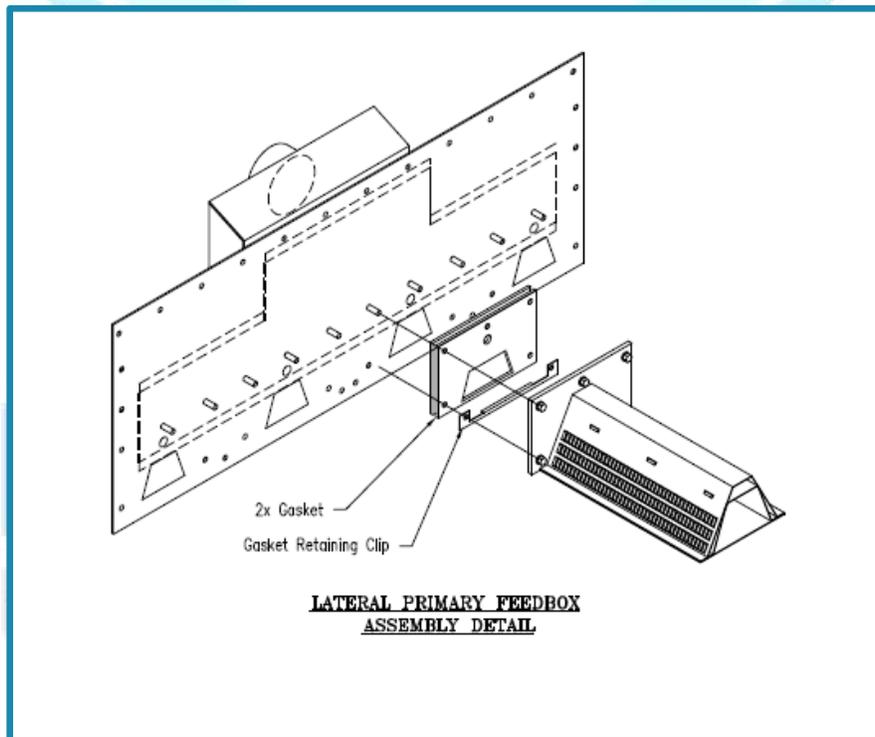
Figure 1 provides perspective on how the lateral to feedbox connection is now made. In the years since this connection was changed, the gasket problem that surfaced at the B.E. Payne WTP has not reappeared.

Figure 1 – Exploded view of the current AWI lateral to feedbox connection.

1. Rather than welding nuts to the back side of the feedbox into which connecting bolts had to be threaded during installation, threaded studs were welded onto the feedbox. This change meant that the gasket can be slid over the studs and properly positioned before the lateral connection is made.
2. Two quarter inch gaskets are used at each lateral to feedbox connection to provide a gasket thickness which insures proper compression when the connection is made. The narrow portion of the gaskets at the bottom of the lateral to feedbox connection is now held in place using a retainer clip to both add extra compression to the gaskets and provide a lip that precludes the gasket ever sliding into the path of the backwash flow.

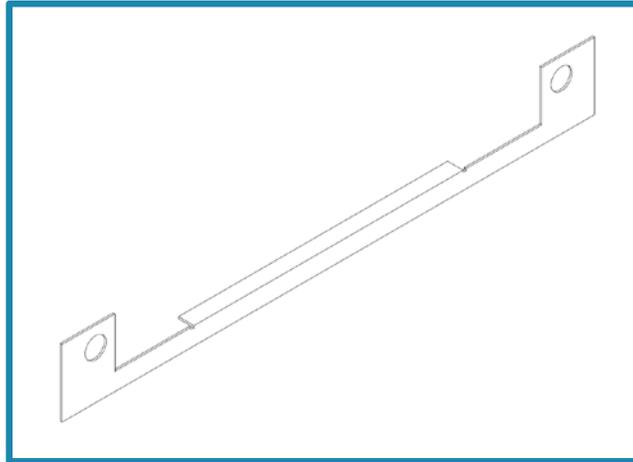
Figure 2 is a view of the gasket retaining clip and the photos in Figure 3 show a clip prior to installation.

Figure 2 – Close-up drawing of the gasket retaining clip with lip.

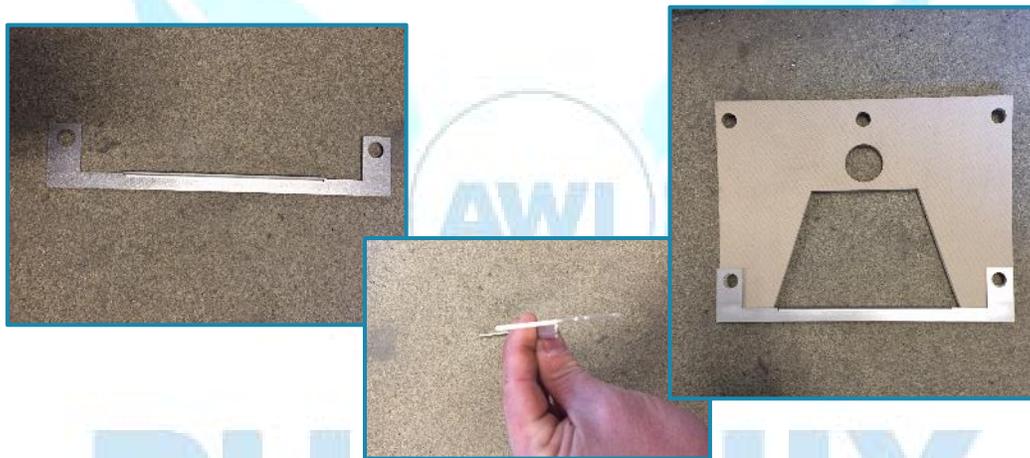
Figure 3 – Close-up view of a gasket retaining clip with lip prior to installation.
