**Key Words:** North Baltimore, Ohio, potable, THM reduction, stratification, mixing

**Owner:** Village of North Baltimore, Ohio; Contact: Andrew Patterson, Superintendent; Telephone: 419-408-2504 or 419-257-2141; Email: [nboh3@wcnet.org](mailto:nboh3@wcnet.org)

USOHPW-LOC1027.001, Last updated: September 16, 2014

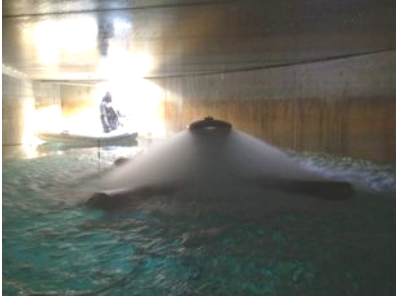
**Photos:** Photo on the left is the SN15 running after installation. The middle photo is showing the two SN15 units in Clearwell # 2. Photo on the far right is showing the SN15 running in the Clearwell.

**SolarBee Installation:** Date: 3/13/2013 One GridBee GS12 (mixer) unit was installed in Clearwell # 1 to increase TTHM production and reduce formation potential before the water entered Clearwell # 2. Two GridBee SN15 Floating Spray Nozzle THM Removal Systems were installed in Clearwell #2. This system was sized to accommodate the peak pumping rate of 2 MGD.
