Key Words: potable, stratification, water age, short-circuiting, chlorine, GS-12

System overview: This standpipe tank serves a population of approximately 14,000 residents. The tank stands 75 ft tall with a 64 ft diameter. Operating water height is approximately 65 ft, yielding a tank capacity of 1.5 MG. The disinfectant utilized in this system is chlorine.

Re: Water District
Tank Mixer – Pilot Program

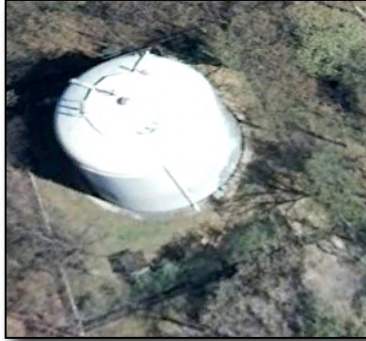
Photos: The left photo is an aerial view of the tank. The middle photo is an image of the GridBee GS-12 submersible mixer. The right photo shows a close-up view of the tank.
