You Mean You Can Fix It?

WESTERN FILTER PLANT

AWI WHITE PAPER – YOU MEAN YOU CAN FIX IT?

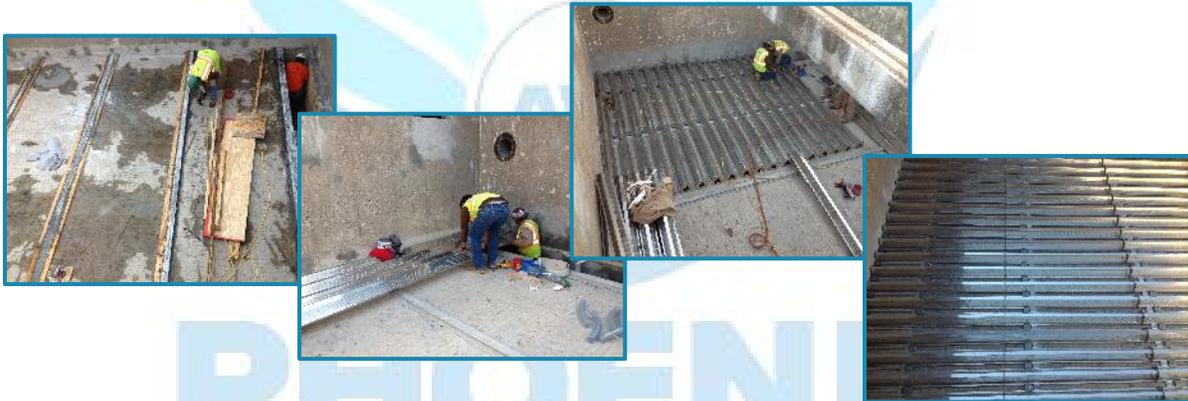
The AWI Underdrain System was installed as designed by the consulting engineer and the installation went smoothly based upon solid work by the contractor coupled with close supervision by AWI.

Work on three filters was completed and everyone thought they were ready for testing prior to being placed into service. To the horror of the consulting engineer, contractor, and AWI Installation Supervisor, the paint system that was used to cover the concrete in the filters and in particular in the filter gullets then began to blister and peel just as the filters were declared ready for testing. Because installation of the filter underdrains was complete, there was no access to the filter gullets for removal of the defective paint system.

quick removal of the AWI Underdrain System by unbolting the underdrain laterals to allow access to the filter gullets. Once the filter gullets were accessible, the coating system was removed from the filter gullets and they were not recoated (based upon this experience and others, AWI now recommends that filter gullets not be coated). The AWI Underdrain System was then reinstalled and the only cost apart from labor was some gasket material and sealant that needed to be replaced during the reinstallation of the underdrain laterals.
